## TI\_2122: Connector latch for I/O board

iCombi Pro / Classic

12/10/2021

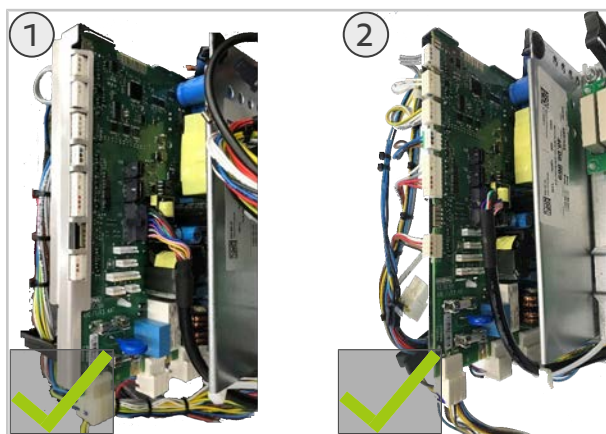
1. With connector latch for I/O board
2. Without connector latch for I/O board

>> Both variants are available on the market and are correct.

To ensure that the connectors are still in the correct position on the I/O board, a connector latch is also attached to guarantee the exact position of the connector.
