## TI\_2211: iVario hand shower drips in park position

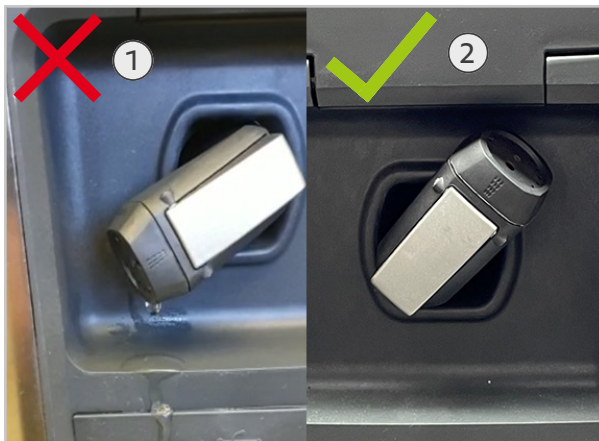
In park position, the hand shower may drip slightly due to the two possible settings (jet and spray). This condition does not indicate a technical defect, but is due to the residual quantity of water in the hand shower head.

The dripping in park position can be avoided (1) by shaking the hand shower after use and positioning it vertically in the holder so that the spray opening points upwards at an angle (2).
