## TI\_2326: Problem with pan valve, lid locking, interruption of pressure mode

iVario Pro 2-S P

27/12/2023

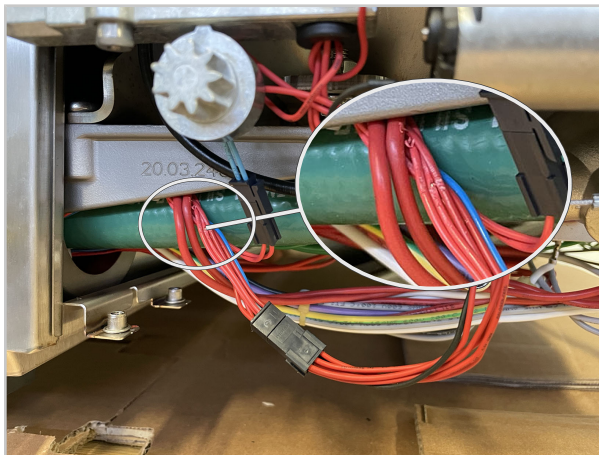
#### Condition of the cable harness

The cable harness running through the axis of the pan may be damaged and have unintended ground faults, which can lead to various problems depending on the damaged wire.

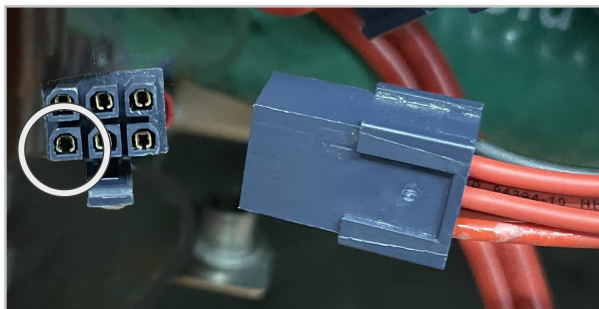
#### Condition of connections of intermediate plugs

The connections of intermediate plugs should be undamaged.

Example of a faulty connection:

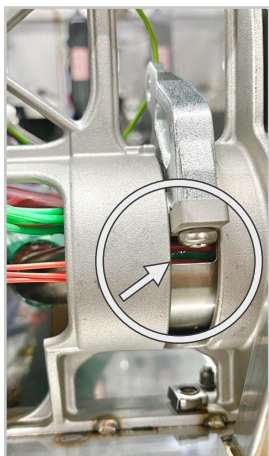
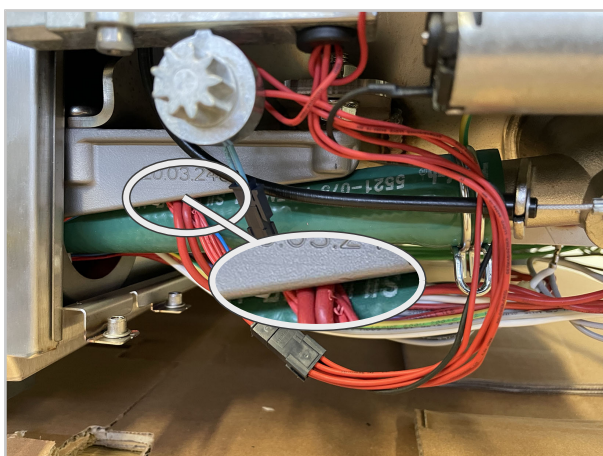
#### Position of the cable harness on the drain pipe

The cable harness must not be pinched by the drain pipe.

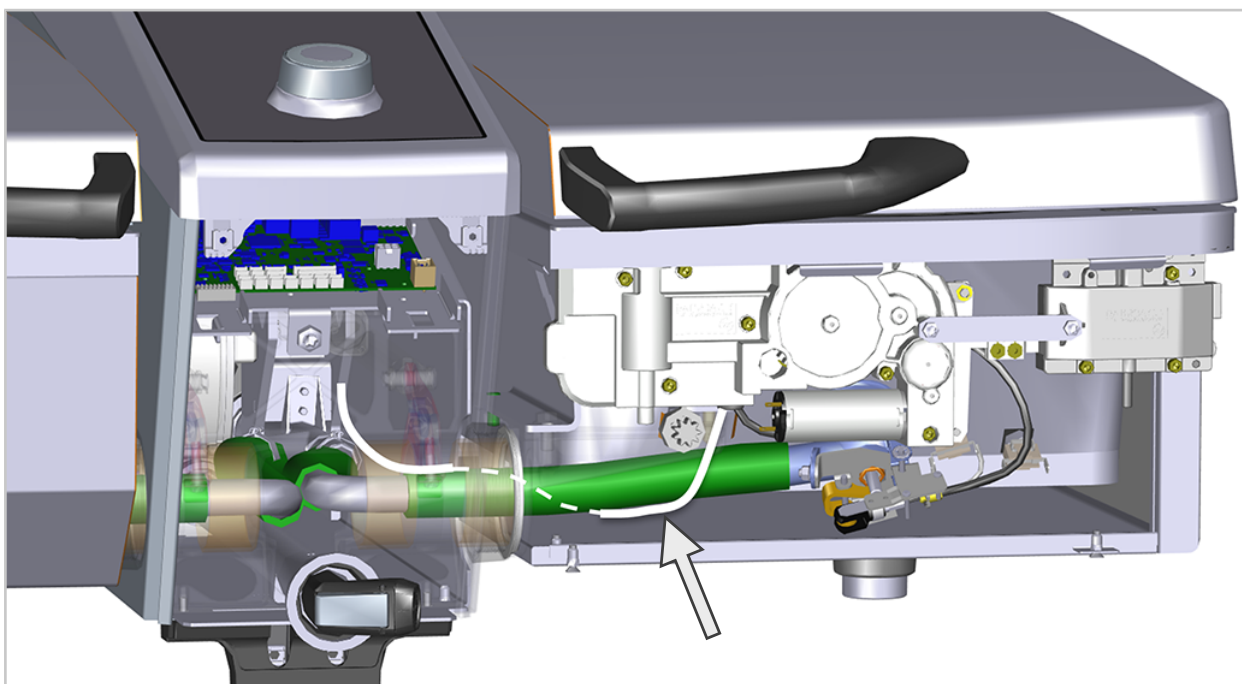
### Routing of the cable harness

The cable harness of the locking system must run from the upper part of the axle passage down behind the drain pipe and come out again under the drain pipe and back up to the locking system at the front.

The following example shows the right side of the unit and applies to the left side accordingly:

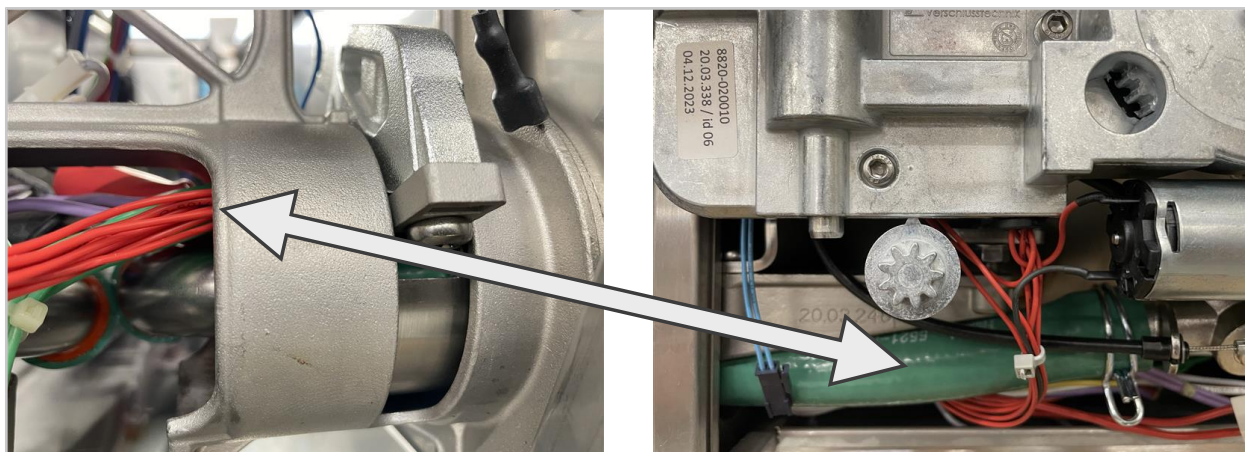
**Position of the cable harness in the axle passage**

The cable harness must remain free in the axle passage.
