TI\_2503: Follow-up check of bolted connection of clamping bearing and left bearing for pan

iVario Pro L / XL

02/04/2025

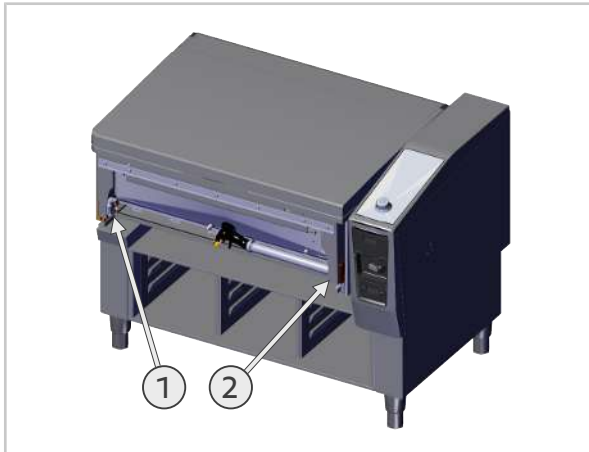
On the left is the **left bearing for pan (1)** and on the right the **clamping bearing (2)**.

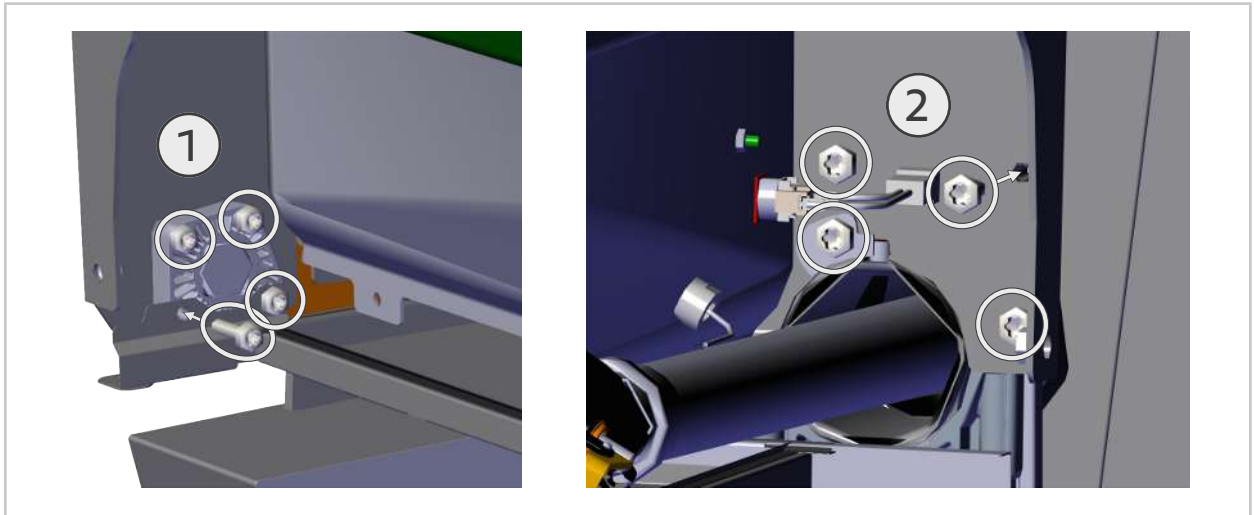
The bolted connection can come loose on individual units and lead to material damage over time.

1. Check on both bearings that all eight screws are tight or loose.

- > **All screws are tight:** No further action is required, complete the steps in this chapter.
- > **Some screws were loose:** Carry out the **bearing bolted connection rework** as described in the following chapter.

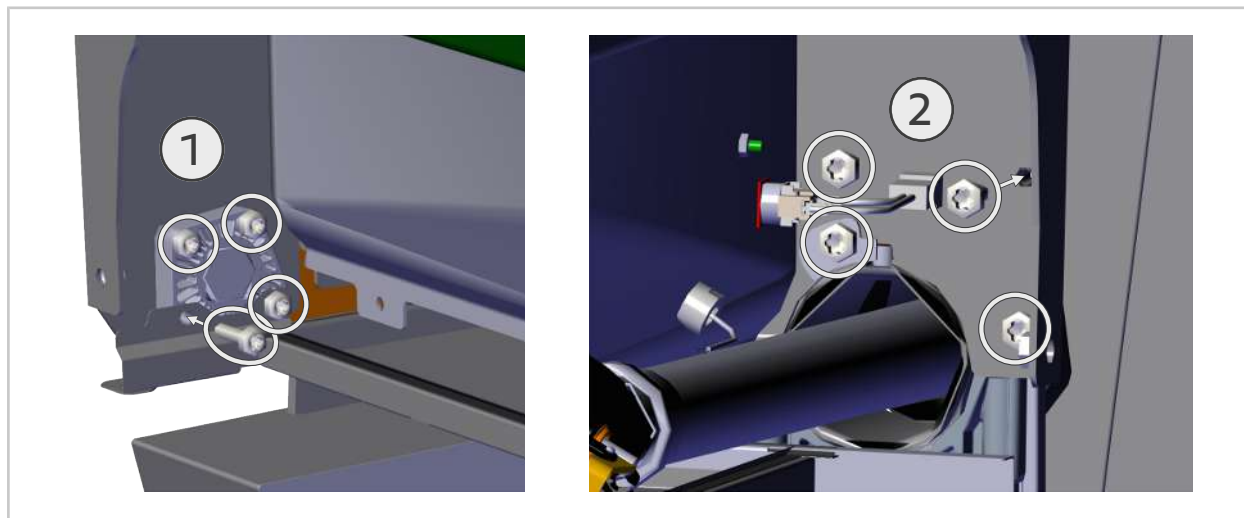
1. To check, always unscrew only one of the bolts from the bearing.

If you have found loose bolted connections during the follow-up check, you must unscrew and clean all screws one after the other, apply a screw lock and retighten to **20 Nm**.

2. Check the screw for traces of copper grease.
3. If there is copper fat on the screw, degrease the screw and the thread in the unit, for example with brake cleaner.
4. Apply a liquid, medium-strength screw lock to the screw.
5. Tighten the screw to **20 Nm**.
6. Repeat the procedure for all the remaining 7 bolts of the two bearings one after the other.  
**NOTICE! Only unscrew one screw at a time to prevent the bearing from moving! The tightening torque of 20 Nm applies to all screws.**
7. Reinstall the pan front panel in reverse order.
8. Enter the reworking carried out in the service level, see next chapter.
