## TI\_2519: Incorrect QR code

iCombi Classic

02/01/2026

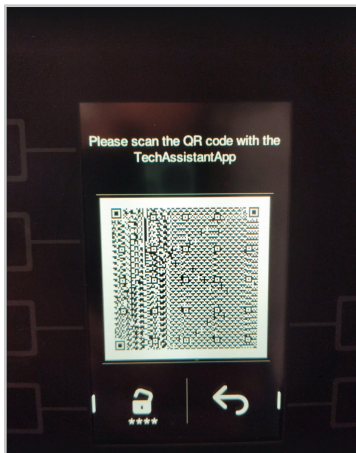
## Error code

We would like to inform you that problems may occur when creating the QR code for the service level. The cause is the installation of software versions LM200-9.0.4 and LM200-9.0.5, which were installed incorrectly. The error only affects control boards (CPU) (42.00.292P) that have been shipped as service parts. Newly delivered iCombi Classic cooking systems are not affected.

- ✓ The unit is switched on and ready to use.
- 1. Insert an empty USB stick for customer data and programs into the unit.
- 2. Download customer data and programs.

- 3. Insert the USB stick with the current software version LM200-9.0.7 or newer and perform a standard software update.
- 4. Open the service level.
- 5. Check whether you can log in again to the service level using the QR code.
- 6. After successful login in the service level, perform an **EEPROM DATA VALIDATION**.  
To do this, navigate to the second page in **SERVICE LEVEL** and select **BASIC SETTINGS**. Select **EEPROM DATA VALIDATION** to perform the validation.
- 7. If the QR code is still displayed incorrectly, perform the following troubleshooting.
