## TI\_2603: Quality defect steam generator water inlet safety fitting

iCombi Pro / iCombi Classic

07/09/2026

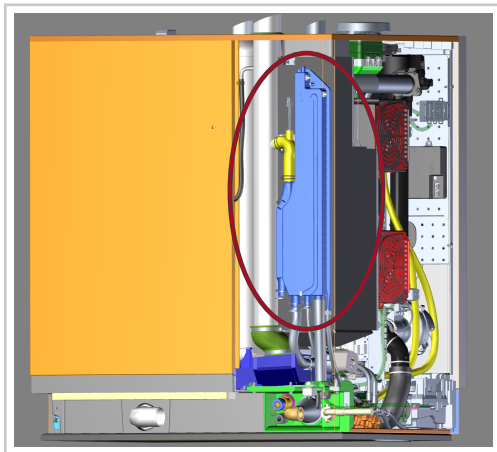
| Component | Item number |
|---|---|
| Safety fitting water inlet steam generator | 87.01.548S |

We would like to inform you that we have received isolated reports of leaks on the steam generator water inlet safety fitting (hereinafter referred to as the Combi water box). The cause is a cracked weld seam on the Combi water box. The cracked weld seam can only occur after transport from Landsberg.

RATIONAL has already identified the cause of the error. The affected period cannot be completely narrowed down. Therefore, install all units with the split rear panel open and check the Combi water box for leaks.

To avoid unnecessary breakdowns, bring the spare part for the Combi water box with you during installation. If necessary, replace the Combi water box immediately.
