MI\_2211: Repair kit for levelling the cover flap

iVario L P / iVario XL P

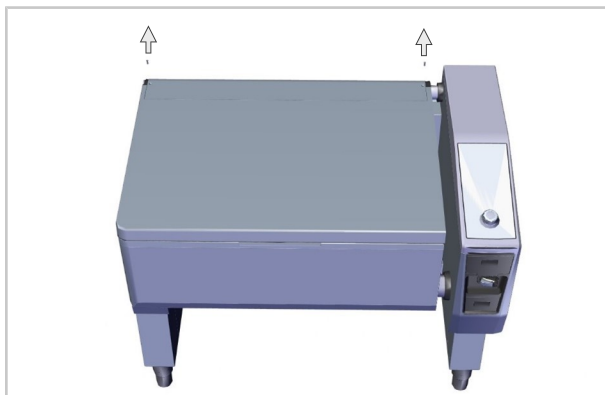
1. Loosen the two screws of the cover flap.

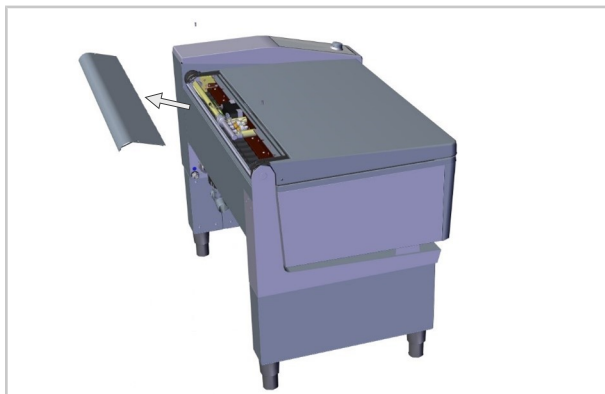
2. Lift the cover flap and remove it.

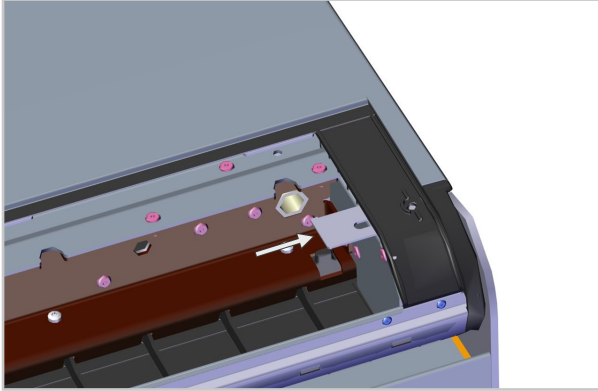
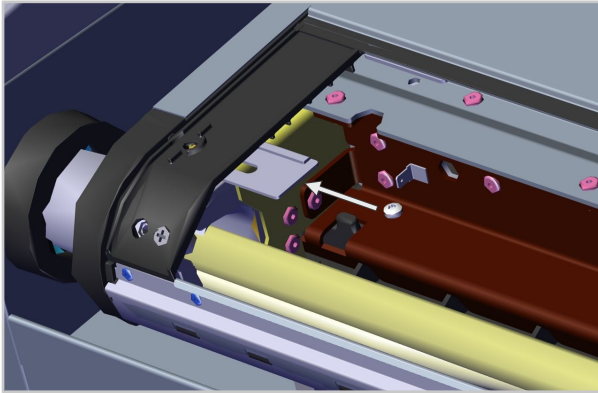
3. Slide the wedges under the cover flap holder on both sides.

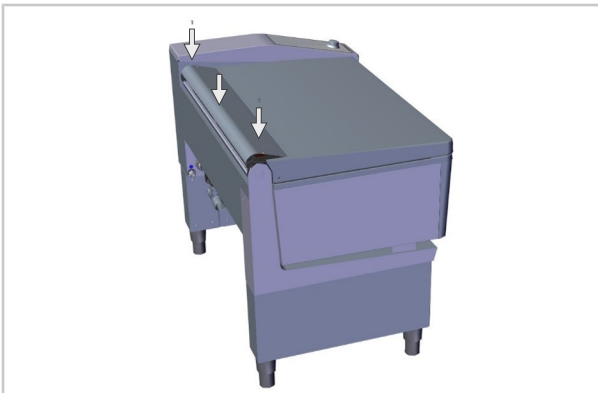
4. Put the cover flap back on and tighten both screws again.

>> The cover flap was successfully levelled.
