TI\_2503: Follow-up check of bolted connection of clamping bearing and left bearing for pan

iVario Pro L / XL

02/04/2025

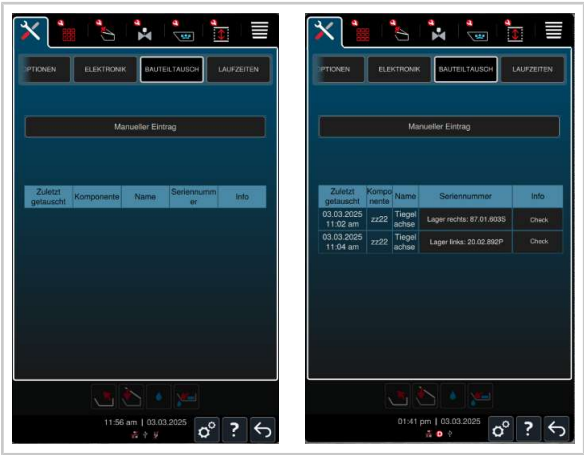
1. Open the service level and check whether the follow-up check has already been carried out.  
**Left:** No service was entered here.  
**Right:** The follow-up check has already been entered here.

2. If you cannot identify an entry, perform a follow-up check as described below.  
>> The check of the entry in the service level is complete.

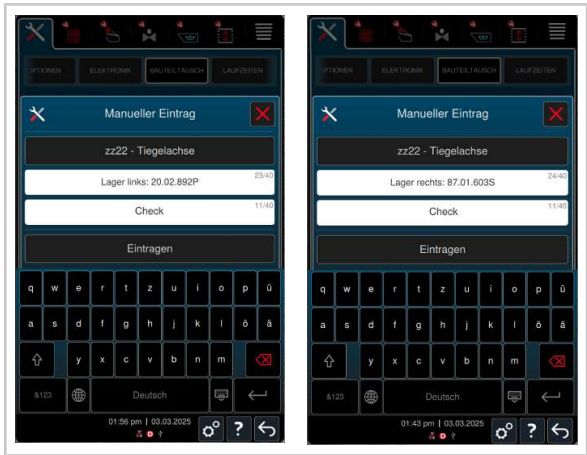
**Select component:** zz22 pan axis  
**Serial number:** Left bearing: 20.02.892P  
**Note:** Check

**Select component:** zz22 pan axis  
**Serial number:** Right bearing: 87.01.603S  
**Note:** Check

1. Enter the follow-up check/rework in the service level as described below:

2. Confirm the manual entries to save them.
