## TI\_2217: Adjustment of stop buffer

iCombi Pro and iCombi Classic electric and gas 20-1/1 and 20-2/1

04/07/2022

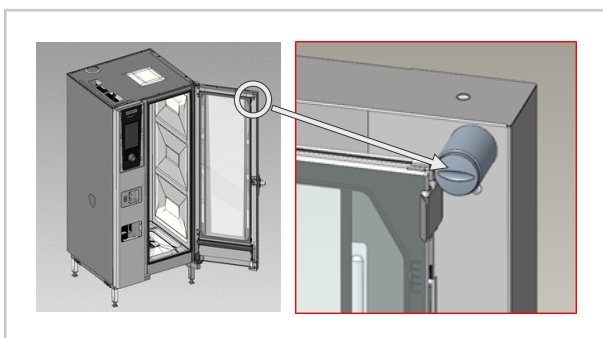
The stop buffer is in the following position:

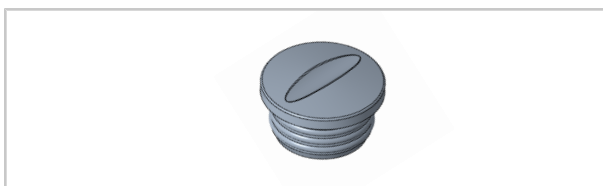
New stop buffer:

In order to prevent the stop buffer Art. no.: 24.05.002P from sticking to the front wall due to vacuum pressure or soiling, which could lead to loss, the stop buffer was adjusted.

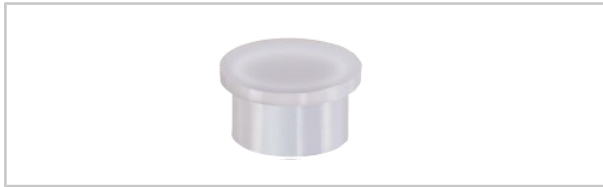
Previously used stop buffer:
