TI\_2310: Material adjustment on the drain opener

iCombi Pro / iCombi Classic 6-1/1 -  
10-2/1

22/05/2023

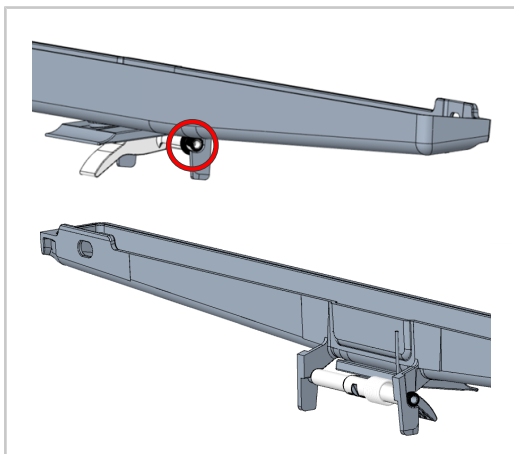
### Old drain opener up to 06/2023

Following a material adjustment on the drain opener (repair kit for drain opener door drip pan, item no.: 87.01.917S), the drain opener is now made of the same material as the door drip pan. The collared bushings are omitted as a result of this change.

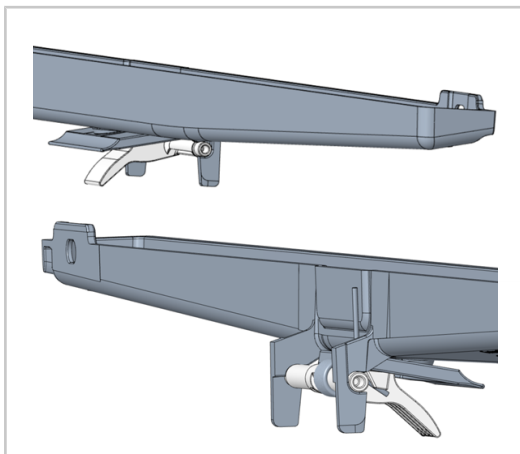
### New repair kit drain opener from 06/2023

From 06/2023, the new drain opener repair kit with item no.: 87.01.917S, the door drip pan 1/1 (incl. drain opener) item no.: 24.05.499S and the door drip pan 2/1 (incl. drain opener) item no.: 24.05.500S is available for service parts.

All affected components are backwards compatible.

No active component replacement is necessary.
